Hydrim C61 G4 Upper Wash Arm Sensor Removing & Reinstalling Part #01-113681S

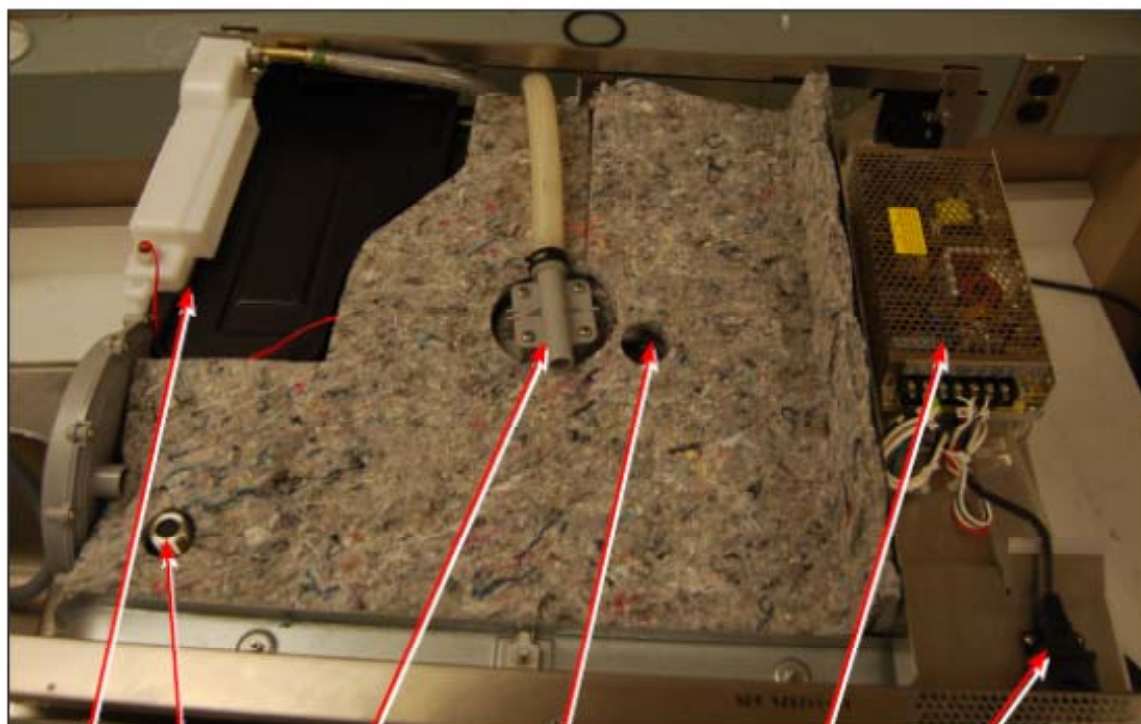
Figure 38

air gap overflow tray test port upper wash arm inlet upper wash arm sensor DC power source USB port

Remove the top cover.

Disconnect black wires 73 & 74.

Unscrew the mounting nut to release the sensor.

Place the sensor into position and hand tighten the mounting nut.

Reconnect the black wires 73 & 74 to the wiring harness.
